# The Importance of Corrosion Protection on Offshore Wind Farms

By Colin Pawsey

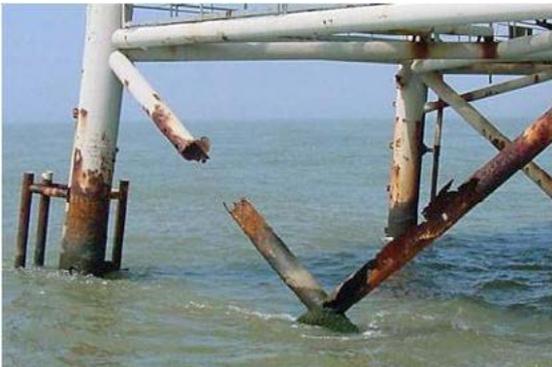
Source: Galvinfo.com

The image below shows severe corrosion of an offshore tower support structure close to the splash zone.
